SITE ASSESSMENT REPORT
FOR
J.E. BERGER SITE
DETROIT, WAYNE COUNTY, MICHIGAN
TDD S05-9602-023
PAN 6F2301SI

August 31, 1996

UNITED STATES ENVIRONMENTAL PROTECTION AGENCY
Emergency Response Branch
77 West Jackson Boulevard
Chicago, Illinois 60604

ecology and environment, inc.

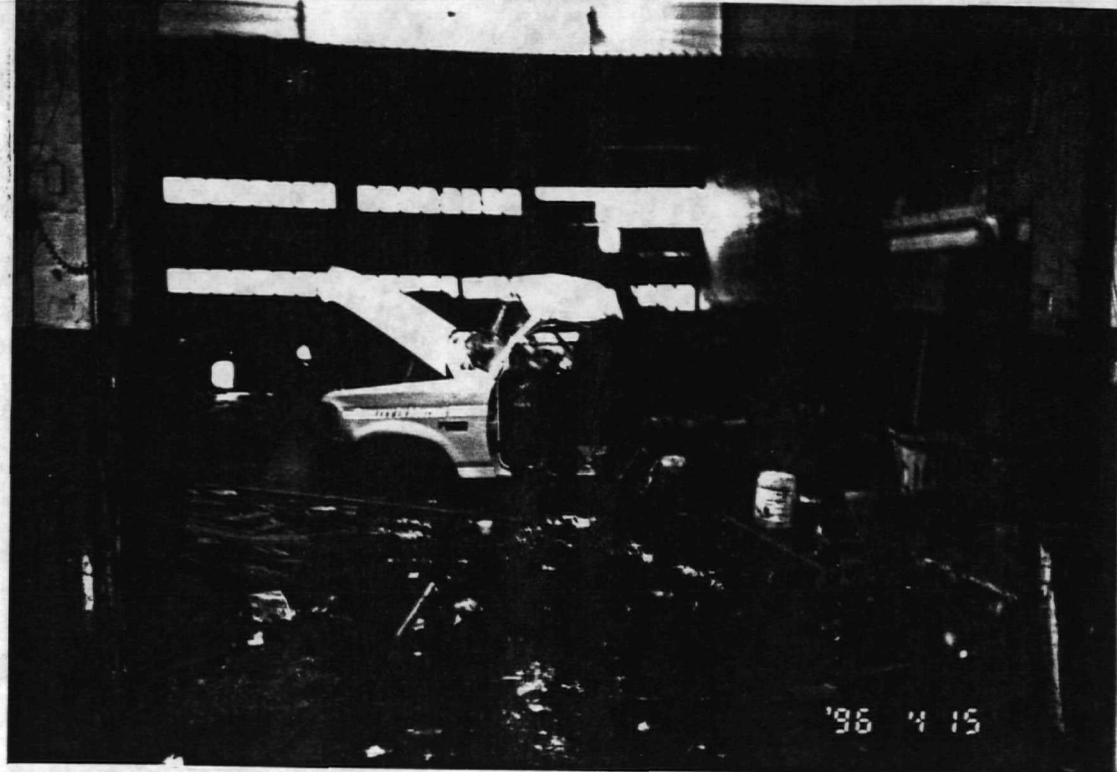
Site: J.E. Berger
 Roll: 1 Photo: 1
 Direction: West
 Camera: Olympus 35mm
 Photographer: C.N. Gibson

Date: April 15, 1996
 Subject: Loading dock entrance; note
 stripped vehicle, and other
 equipment and debris.

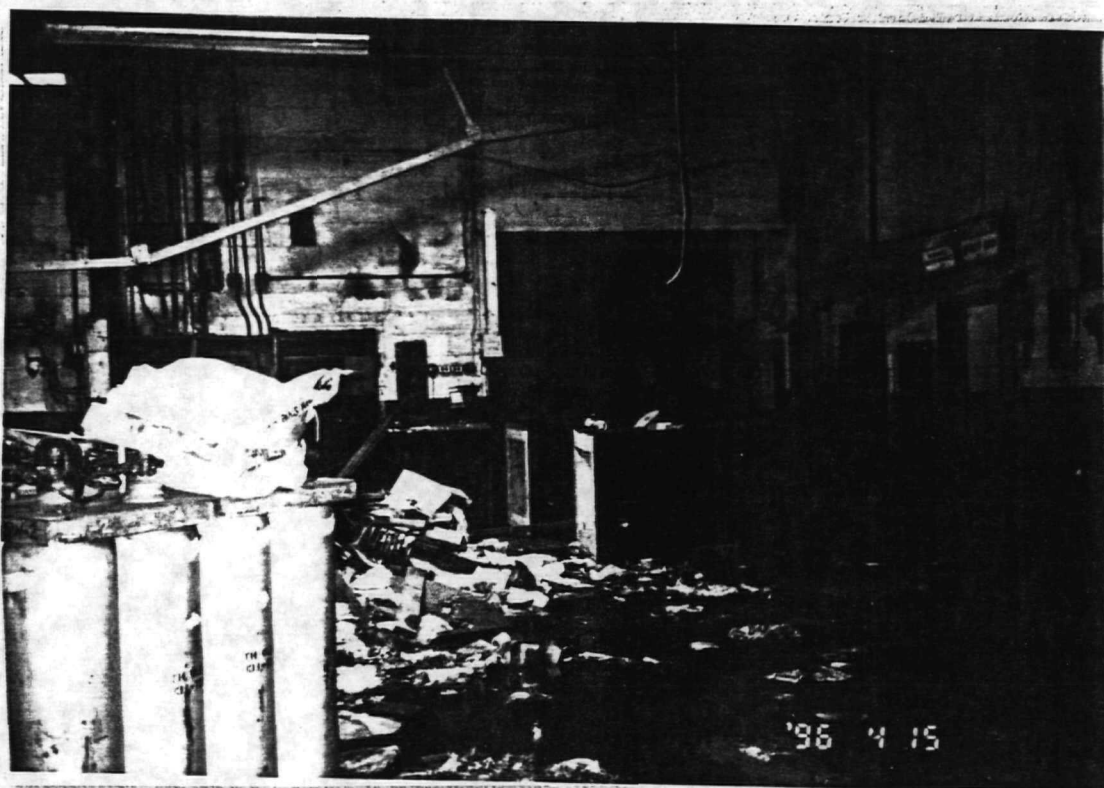
Site: J.E. Berger
 Roll: 1 Photo: 2
 Direction: Southwest
 Camera: Olympus 35mm
 Photographer: C.N. Gibson

Date: April 15, 1996
 Subject: Southwest corner of
 building near first level offices.
 Note kilns and 12 tanks of oxygen.

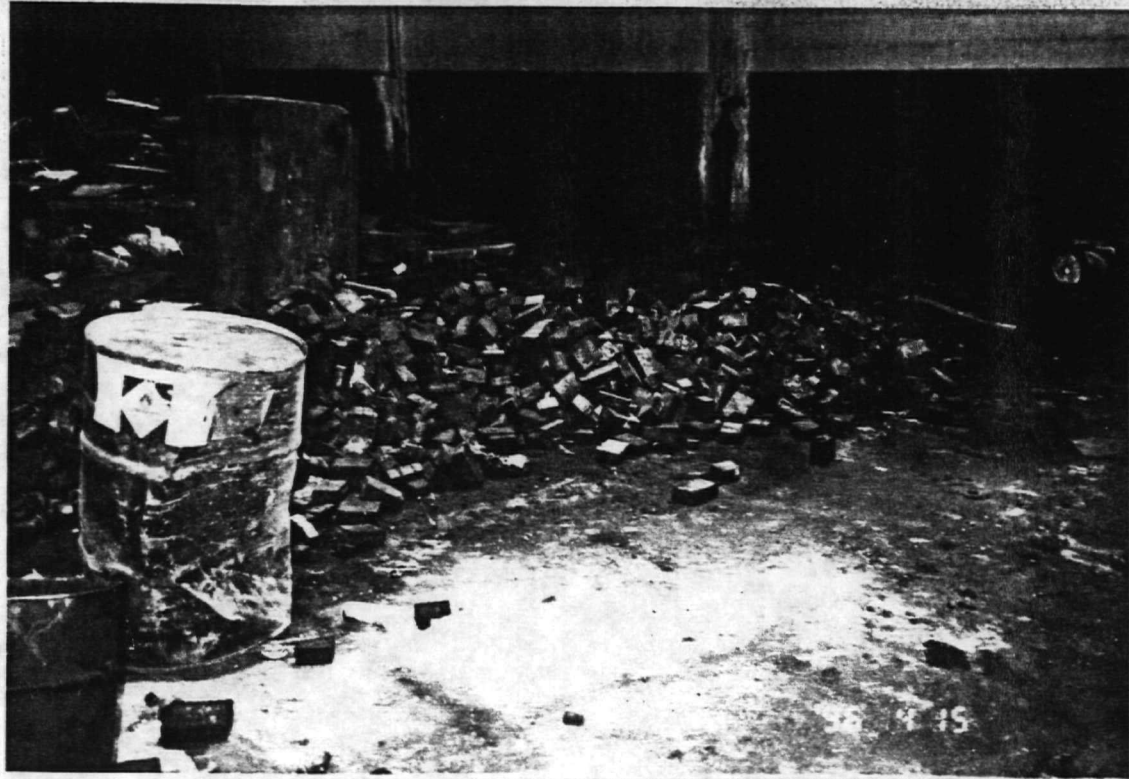
Site: J.E. Berger
Roll: 1 Photo: 4
Direction: South
Camera: Olympus 35mm
Photographer: C.N. Gibson

Date: April 15, 1996
Subject: Pile of oily wooden blocks
and two drums, one marked flammable.

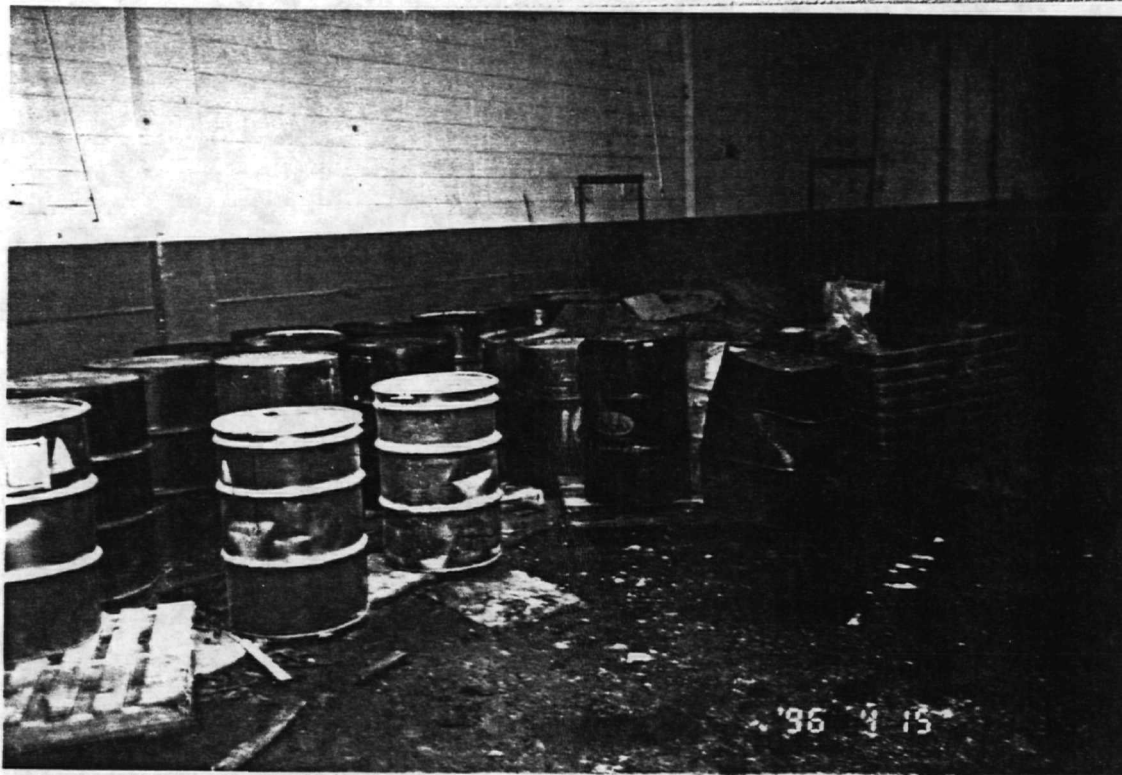
Site: J.E. Berger
Roll: 1 Photo: 6
Direction: North
Camera: Olympus 35mm
Photographer: C.N. Gibson

Date: April 15, 1996
Subject: Approximately 22 55-gallon
drums staged in warehouse. Note
oily ground from historical spills.

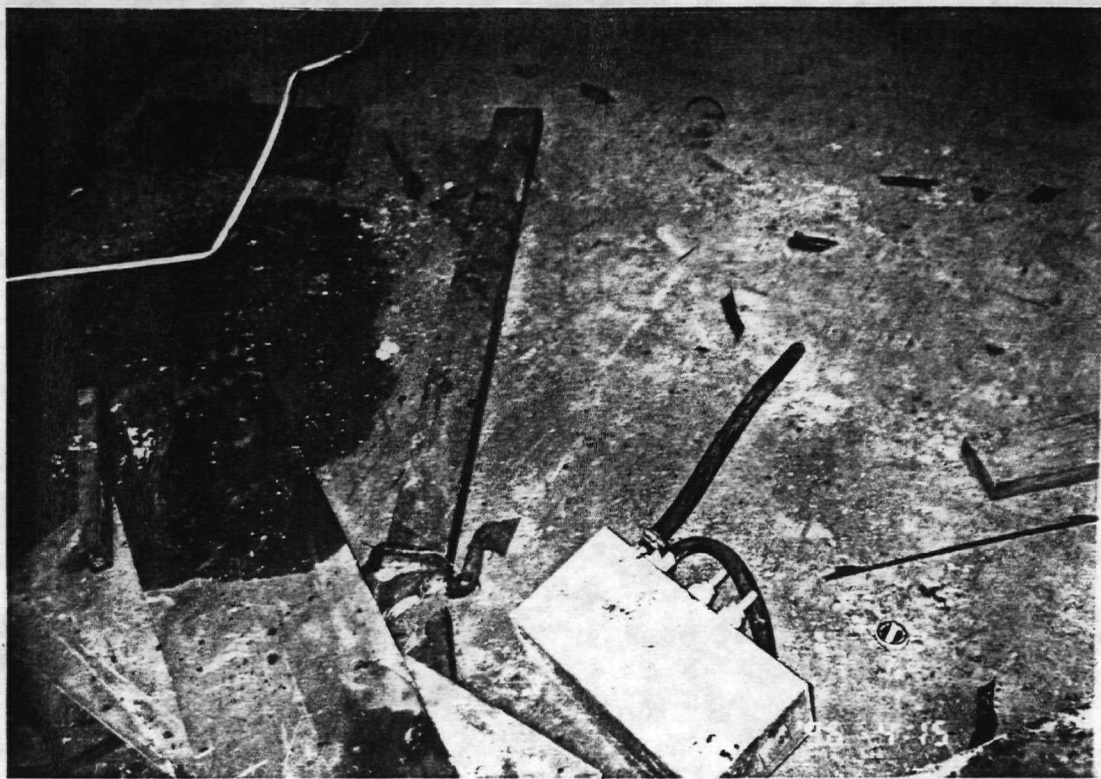
Site: J.E. Berger
 Roll: 1 Photo: 7
 Direction: North
 Camera: Olympus 35mm
 Photographer: C.N. Gibson

Date: April 15, 1996
 Subject: Small capacitor found next
 to staged drums; marked "caution
 PCBs".

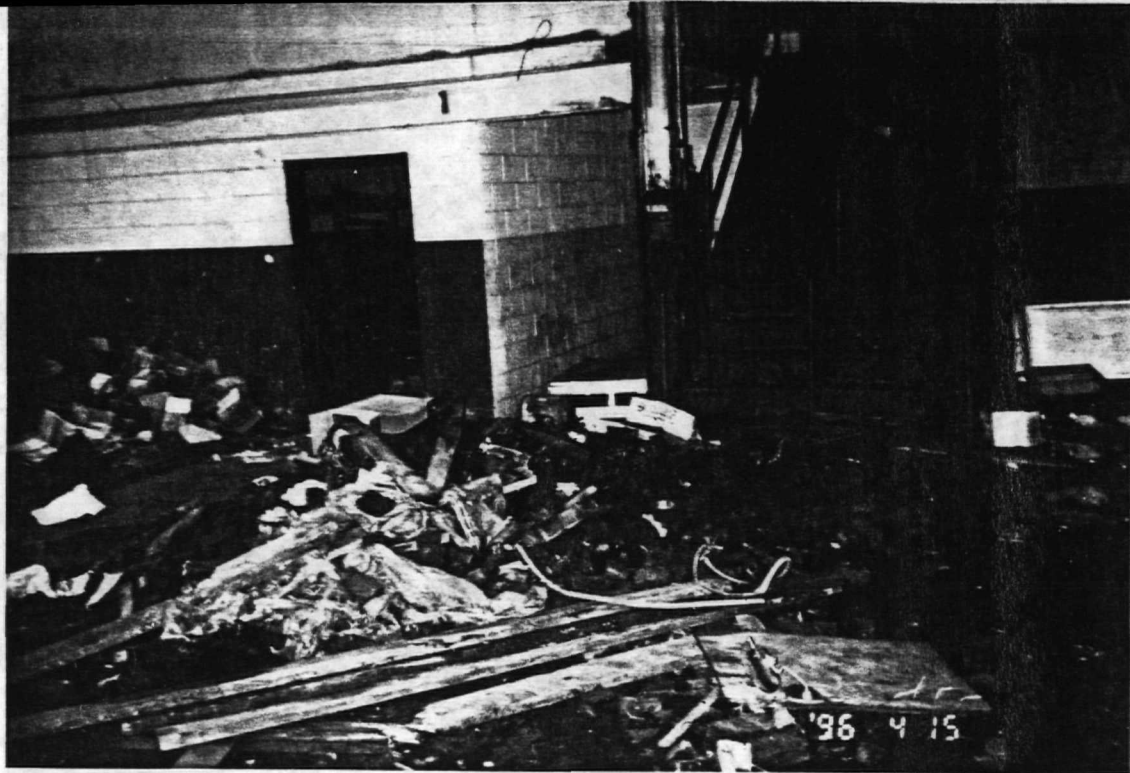
Site: J.E. Berger
 Roll: 1 Photo: 9
 Direction: North
 Camera: Olympus 35mm
 Photographer: C.N. Gibson

Date: April 15, 1996
 Subject: Piles of wooden blocks and
 other debris; stairway to second and
 third levels of building.

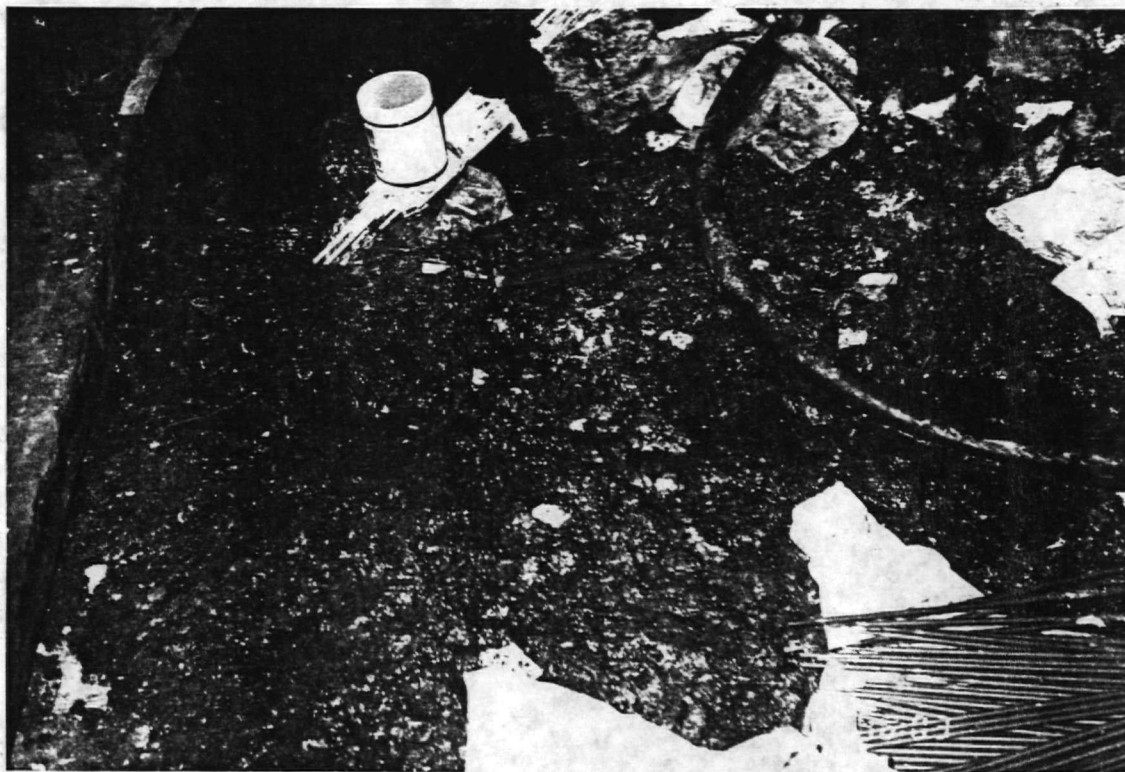
Site: J.E. Berger
 Roll: 1 Photo: 10
 Direction: West
 Camera: Olympus 35mm
 Photographer: C.N. Gibson

Date: April 15, 1996
 Subject: Sludge on the floor of the
 loading dock bay area from which
 sample JEB1 was collected.

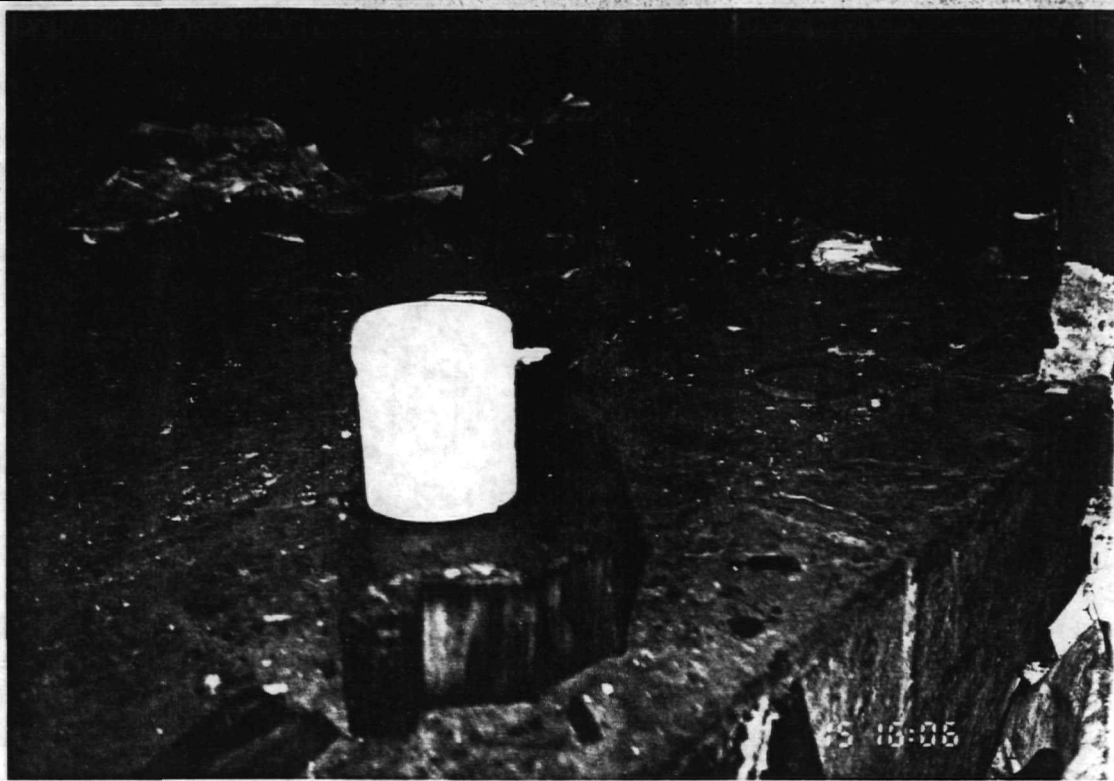
Site: J.E. Berger
 Roll: 1 Photo: 11
 Direction: West
 Camera: Olympus 35mm
 Photographer: C.N. Gibson

Date: April 15, 1996
 Subject: Oil-soaked wooden block on
 loading dock from which sample JEB2
 was collected.

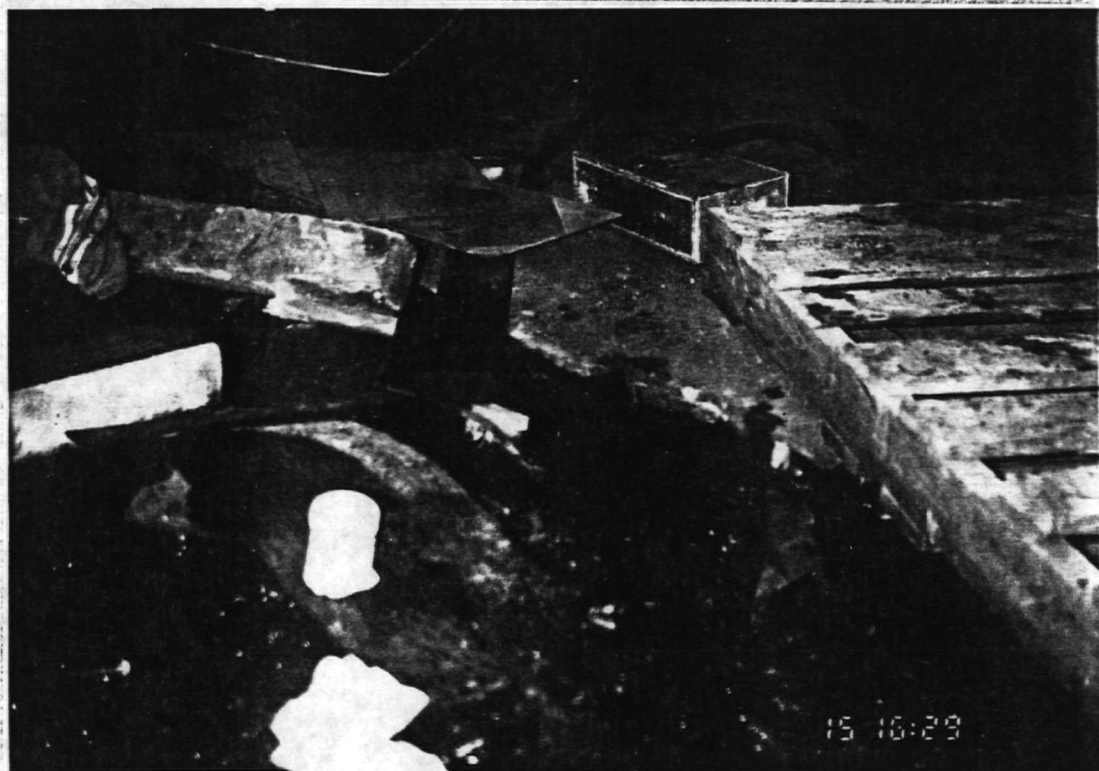
Site: J.E. Berger
 Roll: 1 Photo: 15
 Direction: North
 Camera: Olympus 35mm
 Photographer: C.N. Gibson

Date: April 15, 1996
 Subject: Oil-soaked dirt from which
 sample JEB6 was collected. Note
 proximity of capacitor.

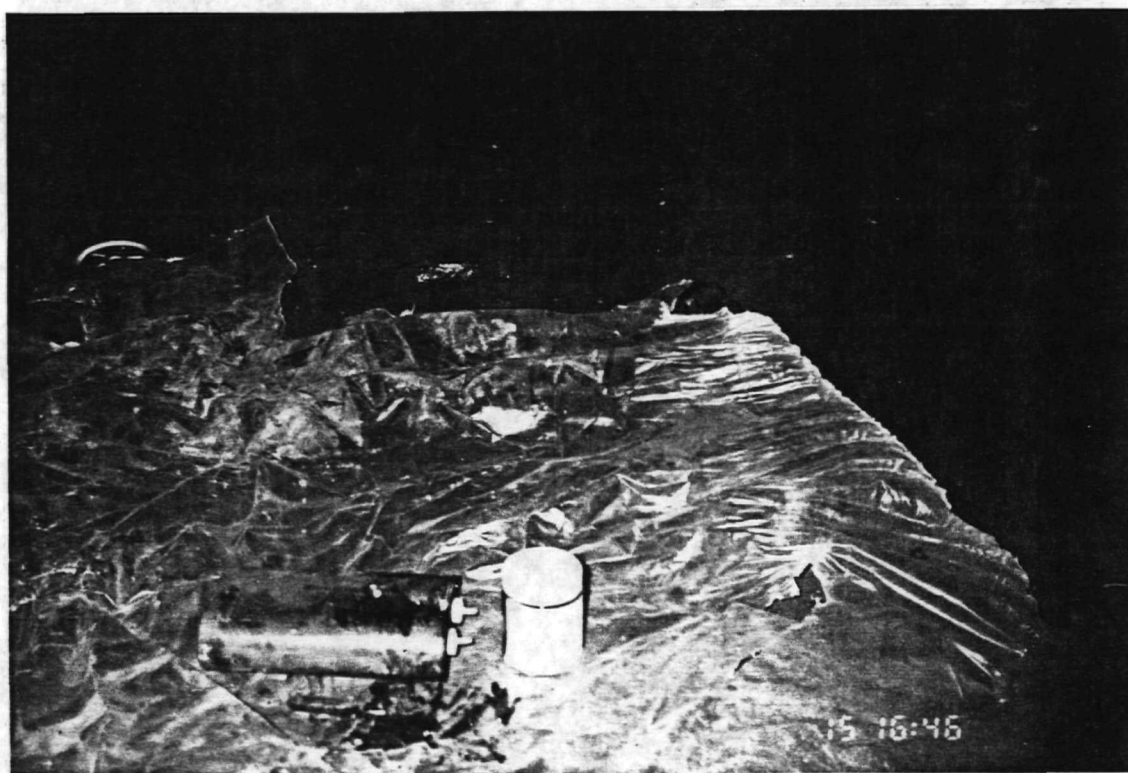
Site: J.E. Berger
 Roll: 1 Photo: 17
 Direction: North
 Camera: Olympus 35mm
 Photographer: C.N. Gibson

Date: April 15, 1996
 Subject: Capacitor found in bin near staged drums. Sample JEB7 was collected from the capacitor.

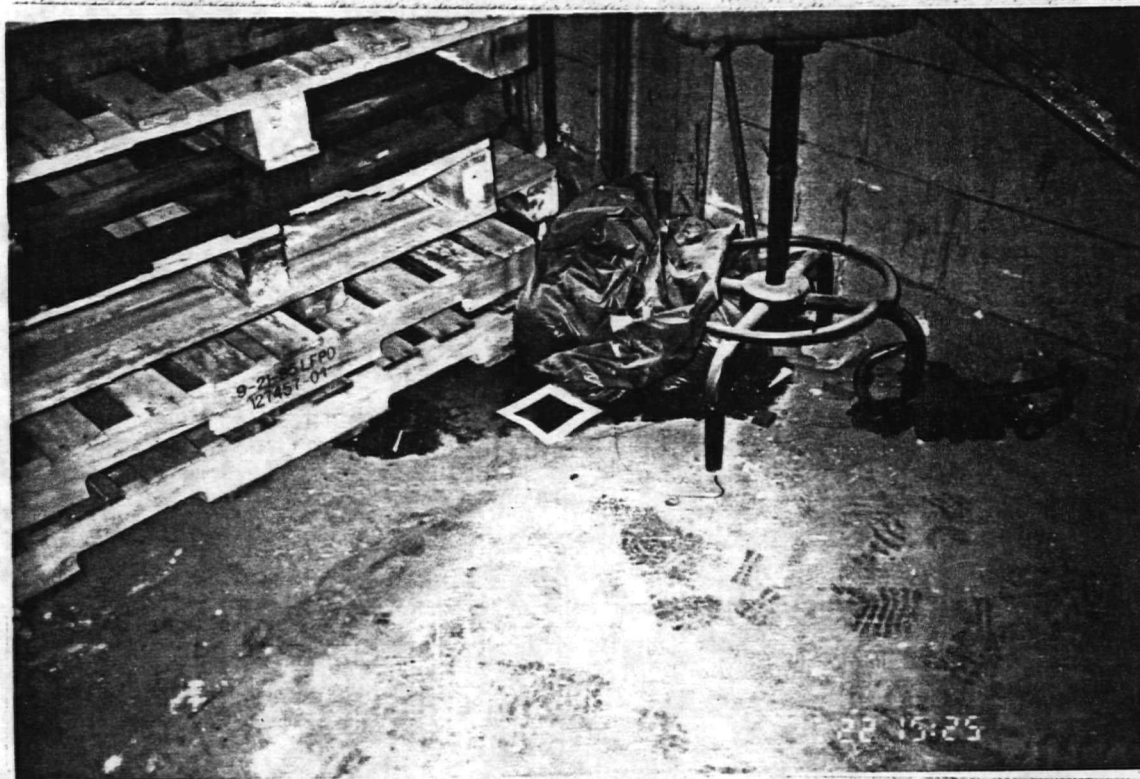
Site: J.E. Berger
 Roll: 2 Photo: 4
 Direction: North
 Camera: Olympus 35mm
 Photographer: C.N. Gibson

Date: April 22, 1996
 Subject: Wipe sample (JEB15) taken
 from the north floor at the Detroit
 Reclaimed Brick warehouse (5335
 Bellevue).

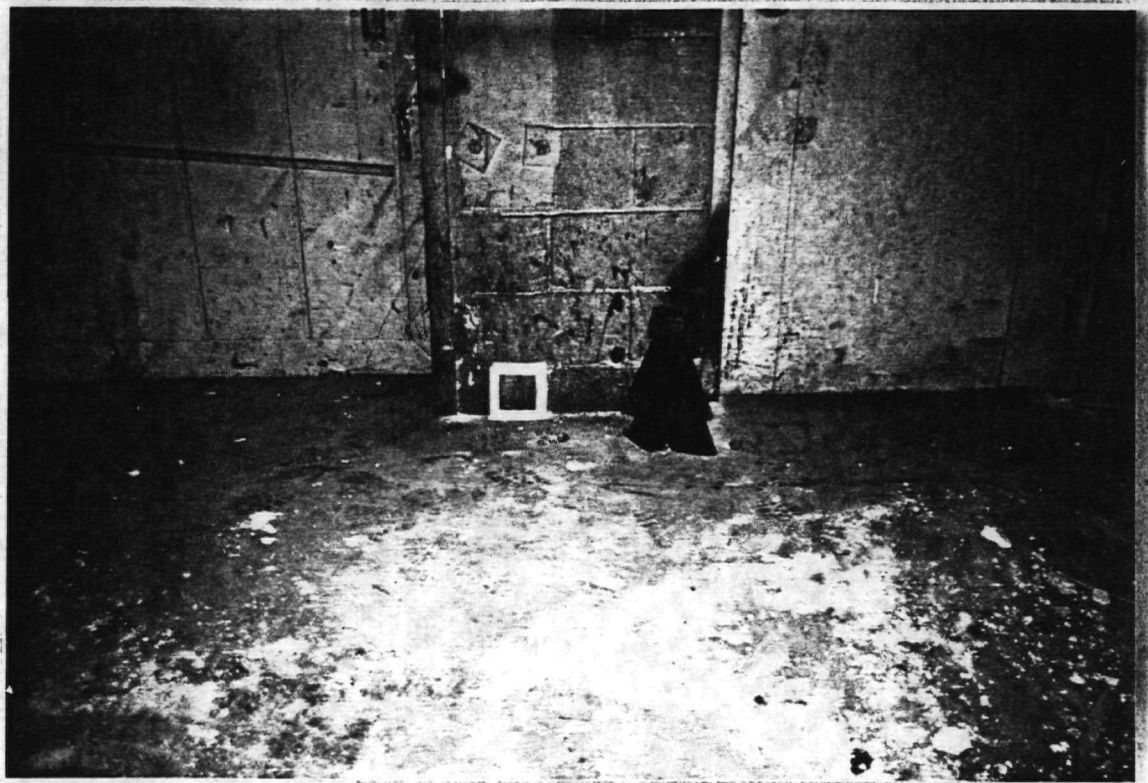
Site: J.E. Berger
 Roll: 2 Photo: 5
 Direction: North
 Camera: Olympus 35mm
 Photographer: C.N. Gibson

Date: April 22, 1996
 Subject: Wipe sample (JEB16) taken
 from the north wall at the Detroit
 Reclaimed Brick warehouse (5335
 Bellevue).

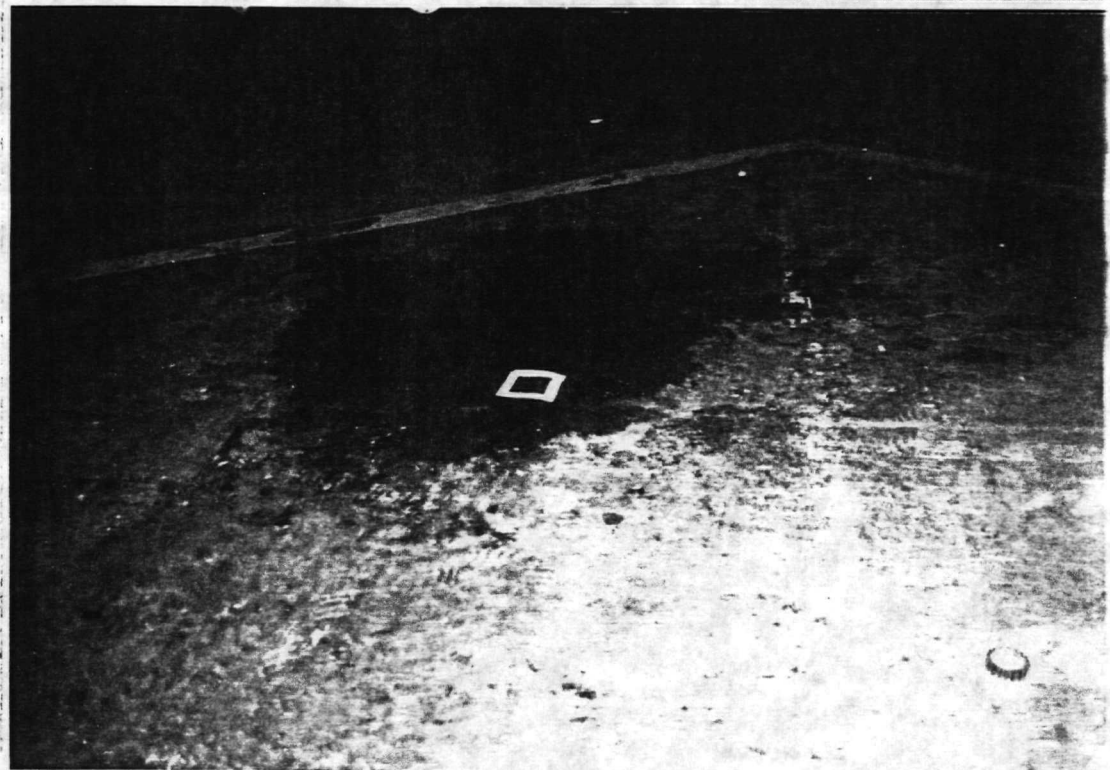
Site: J.E. Berger
 Roll: 2 Photo: 6
 Direction: North
 Camera: Olympus 35mm
 Photographer: C.N. Gibson

Date: April 22, 1996
 Subject: Wipe sample (JEB17) taken
 from stained floor in the Doug Beat
 Electric warehouse.

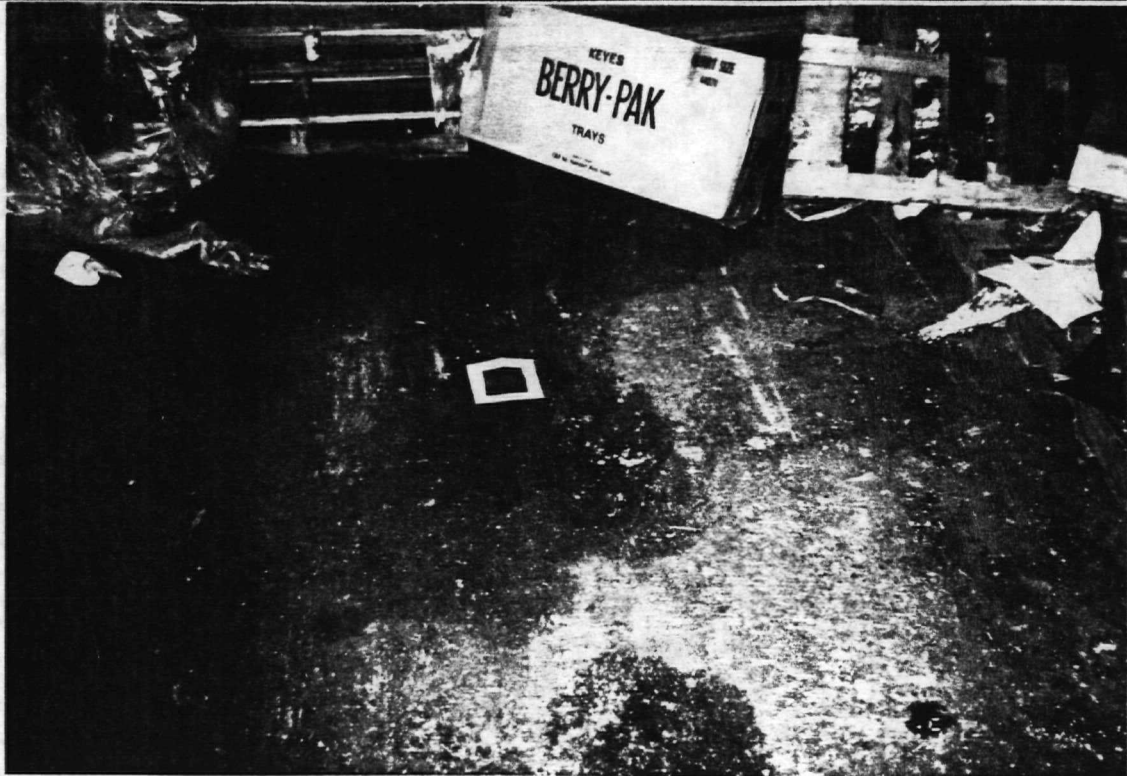
Site: J.E. Berger
 Roll: 2 Photo: 8
 Direction: South
 Camera: Olympus 35mm
 Photographer: C.N. Gibson

Date: April 22, 1996
 Subject: Wipe sample (JEB19) taken
 from the southcentral floor in the
 Champion Paper Company warehouse.

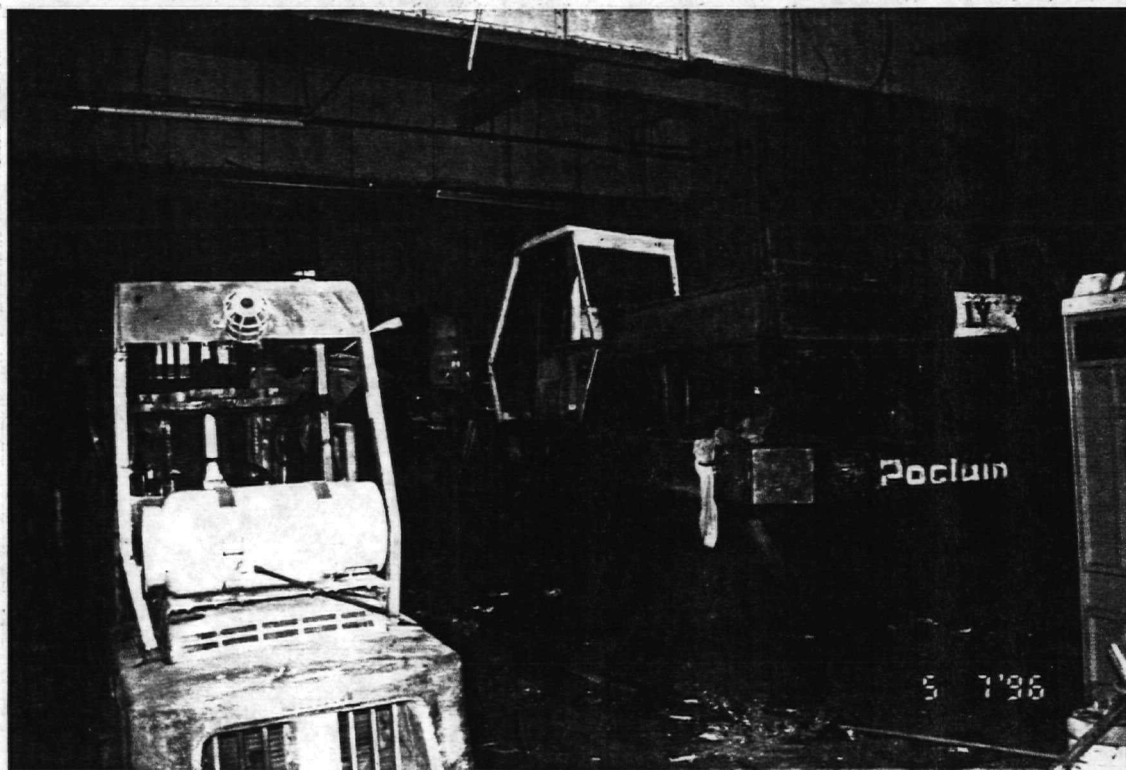
Site: J.E. Berger
 Roll: 2 Photo: 12
 Direction: East
 Camera: Minolta 35mm
 Photographer: C.N. Gibson

Date: May 7, 1996
 Subject: Excavator and forklift in
 the loading dock bay area of 5300
 Bellevue.

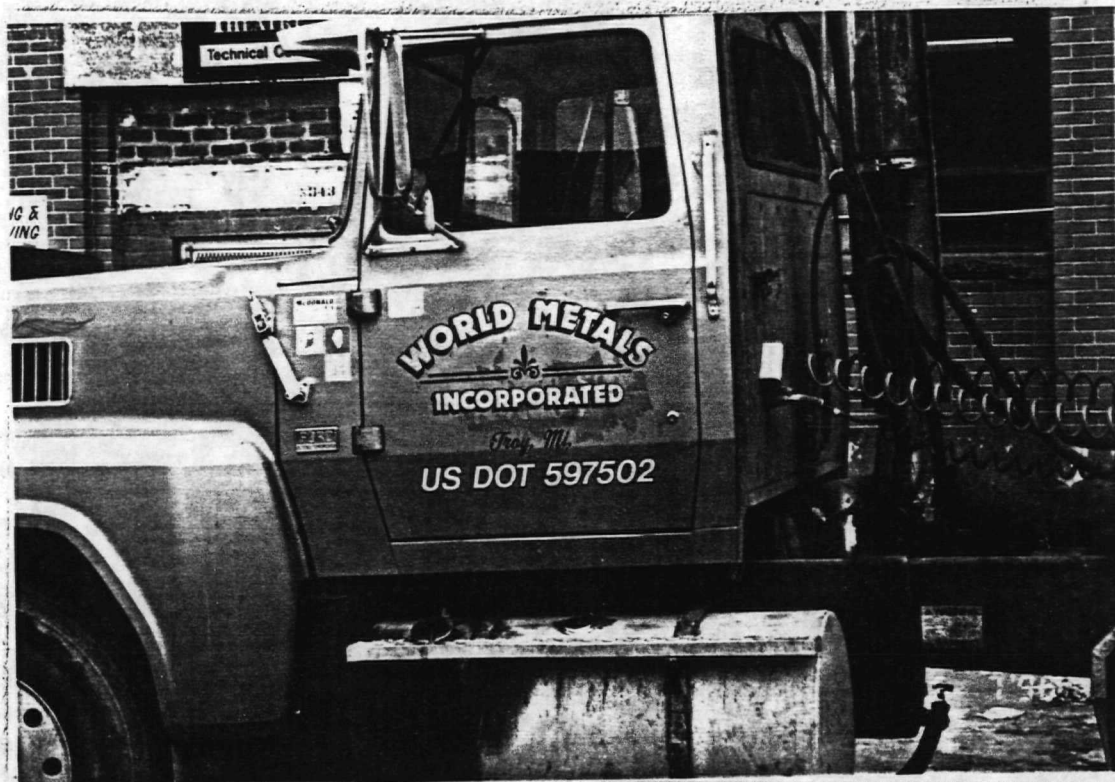
Site: J.E. Berger
 Roll: 2 Photo: 15
 Direction: West
 Camera: Minolta 35mm
 Photographer: C.N. Gibson

Date: May 7, 1996
 Subject: Semi-truck and rolloff box
 for moving items from the warehouse.
